ATTACHMENT C
RCRA 3012 SITE INSPECTION COMMENTS
RICHMOND TANK CAR COMPANY
TX #05746

ATTACHMENT D
SITE LOCATION

**RICHMOND TANK
CAR COMPANY**

HAZSIT #05746

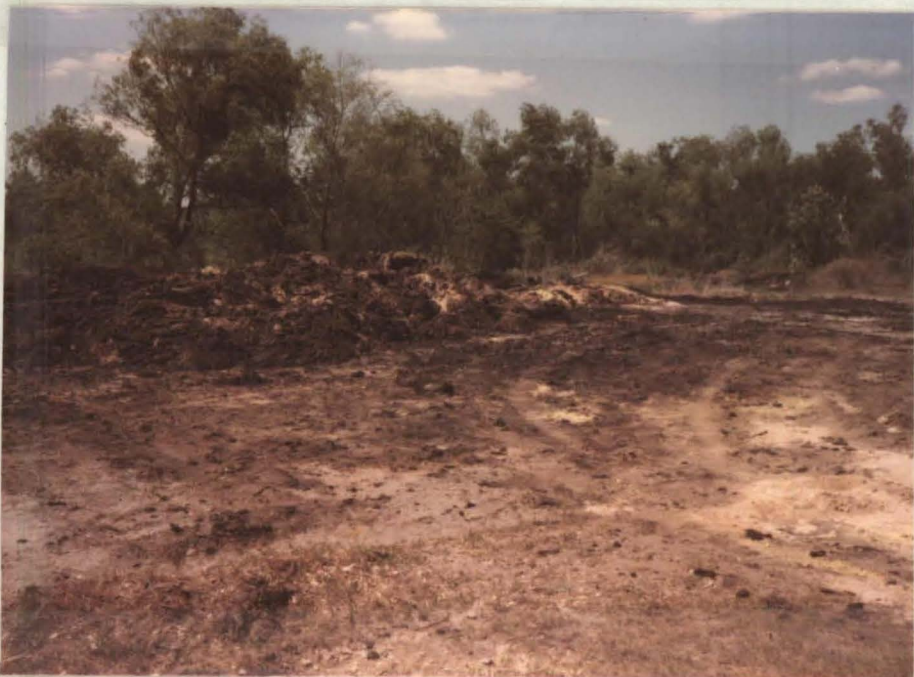
Comments: Float consolidation

area where the float from
oil/water separator are mixed
with sand, gravel and sulfur
to a littable level.

The piling area of solidified floating material is not protected from runoff washout. The material is Class I non-hazardous.

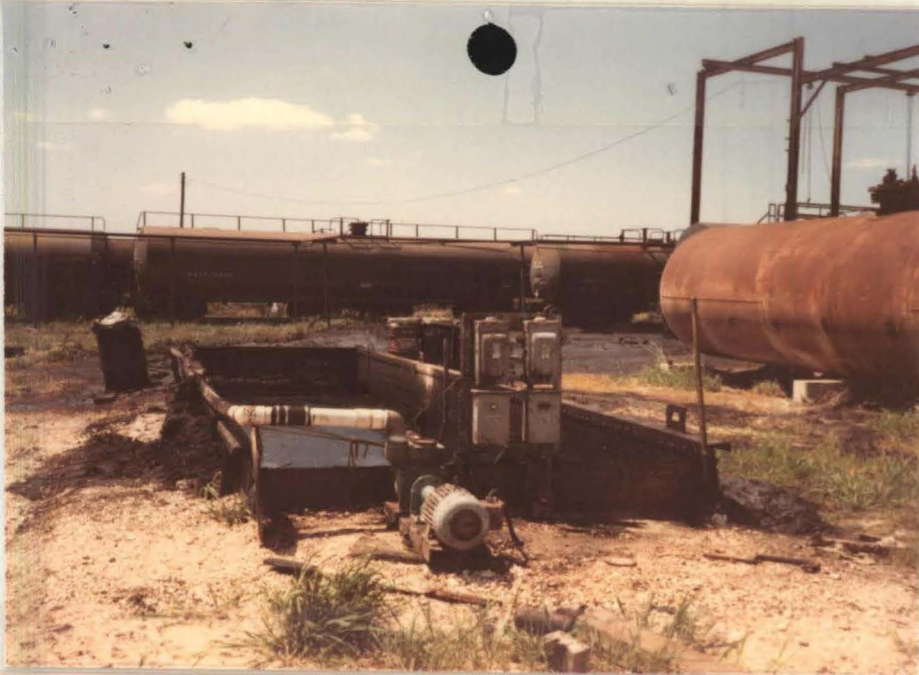
5/10/84 3pm west

Comments: Below-grade oil/water separator; piles of float on both sides; leakage of washwater into soil.

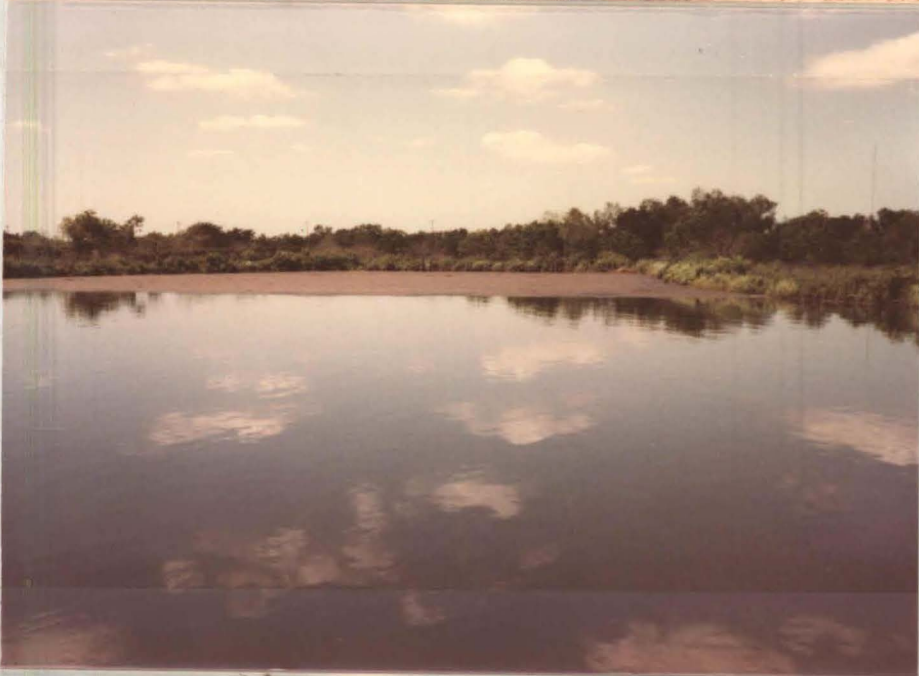
5/10/84 3pm west

Black colored floating material covers about 20-25% of pond surface.

Comments: Part of waste lake; floating pellets & oily material;
